Glass Tile Application

Door Installataion Methods For Glass Tile

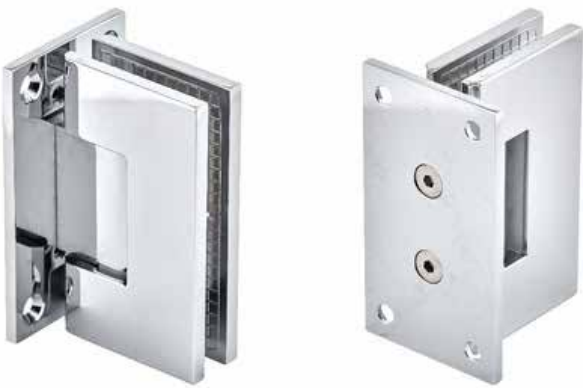
Standard Hinges:
Four Holes Per Hinge

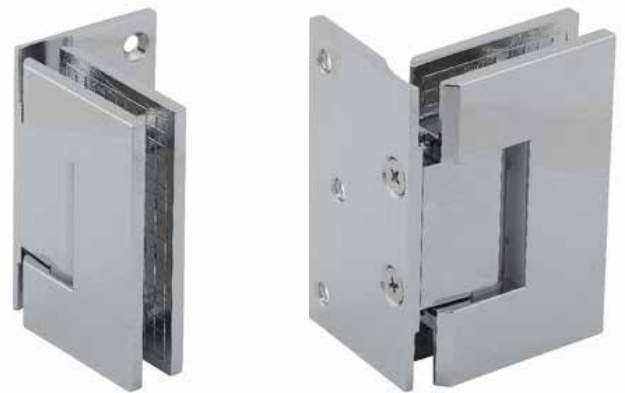
Off-Set Hinges:
Three Holes Per Hinge

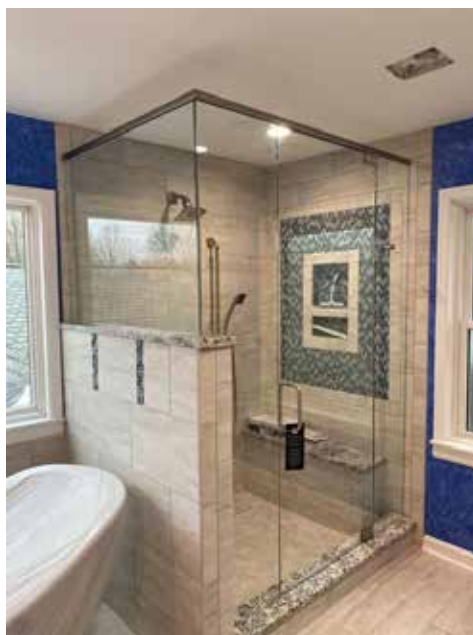
Header System, With Pivot Hinge: One Hole Per Side, Two Holes Total

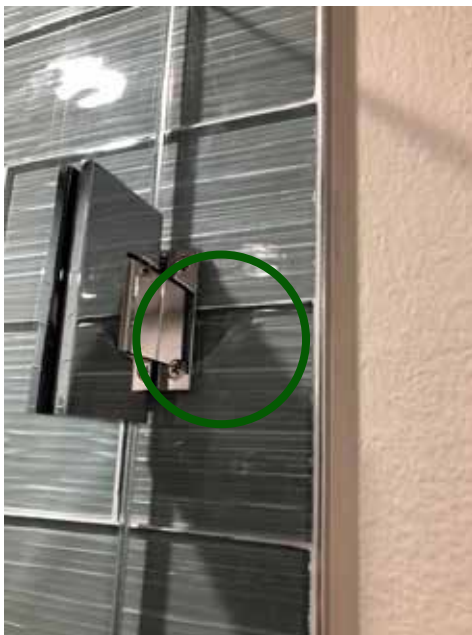
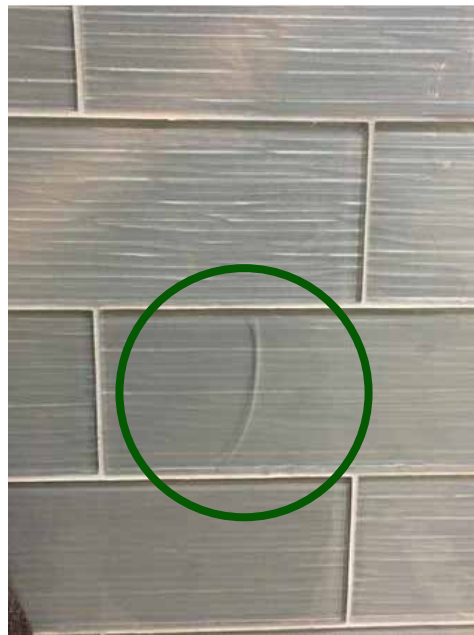
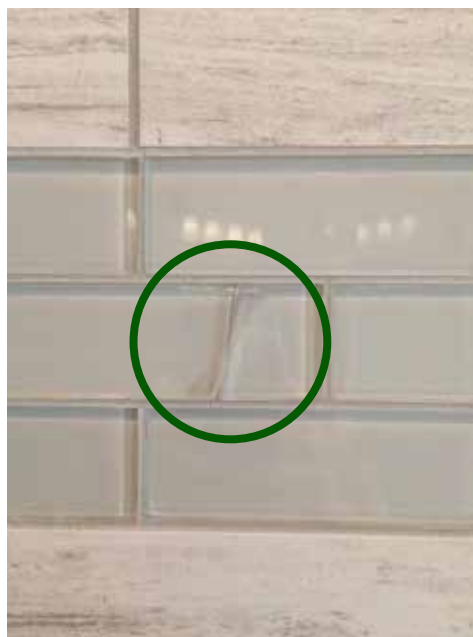
What Glass Tile Looks Like When Cracked

It is possible that the glass tile will crack, "run" or "splinter," but this does not mean the door isn't anchored properly to the wall. Alluring Glass' highly successful/proven method of drilling through glass tile, into the subsurface, provides structural integrity, again, with minimal cracking of the tile, If the tile does crack, a lot of the times the cracks are superficial.

Some clients have chosen to replace the glass tile when that happens. However, many times the cracks are covered or hidden by the hinge backplate. If the tile is replaced after cracking, the installation of the shower enclosure is put on hold until the tile is replaced.
