GREEN HUE IN GLASS

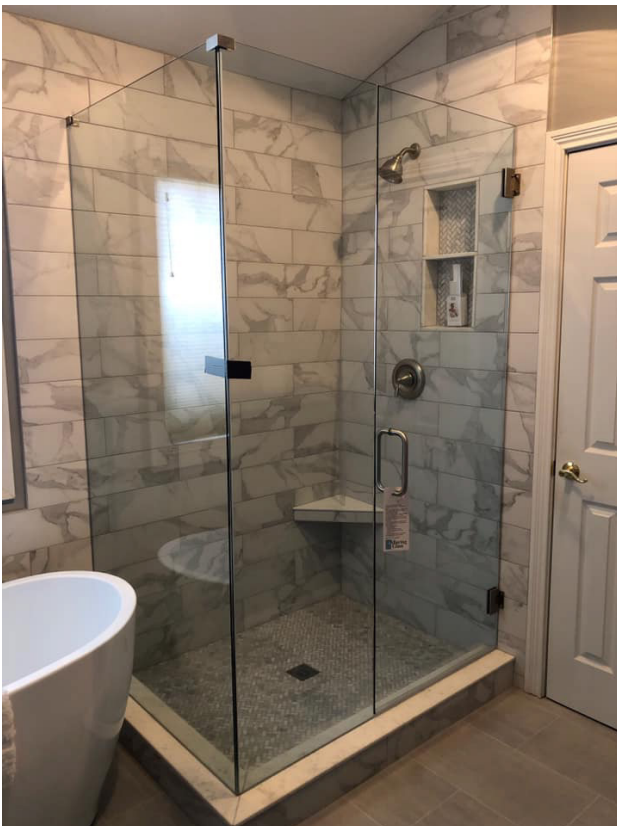
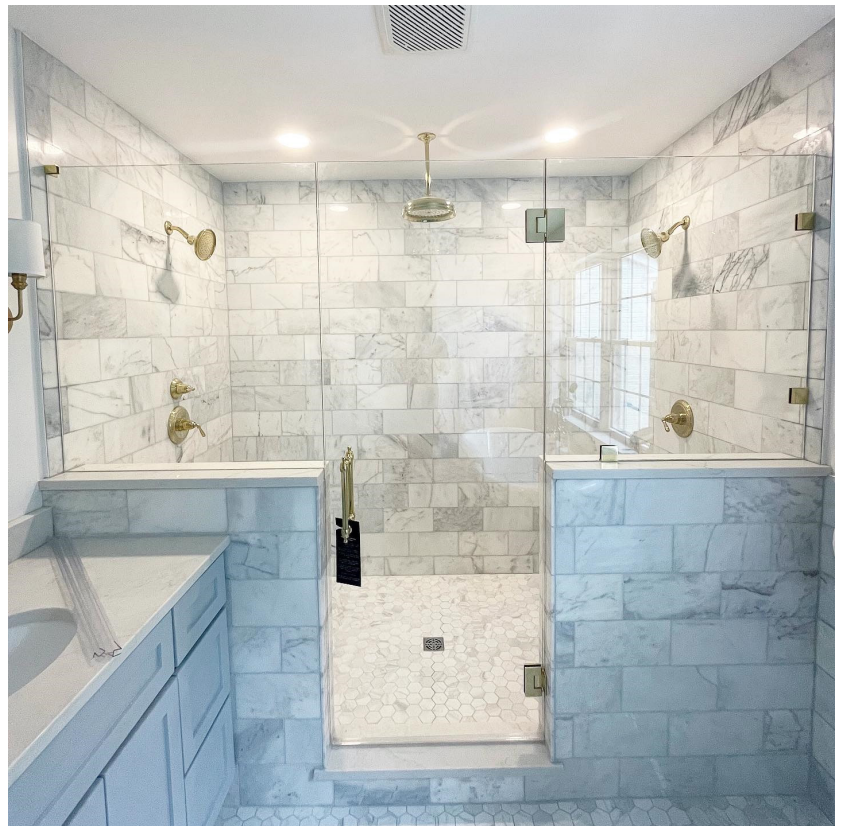
Please refer to the attached photos for comparison: one shows a well-lit application where the green hue is barely noticeable, and the other demonstrates a setting with less lighting, where the green tint is more apparent.

The green tint often seen in glass is caused by iron content used during the manufacturing process. While some find this green hue appealing, others prefer a clearer look. To address this, low-iron glass is available, which significantly reduces the green coloration.

Over the years, we've observed that strong lighting within a shower—particularly when it's brighter than the surrounding area—can make the green hue virtually disappear.
