AG | A L L U R I N G

GREEN HUE IN GLASS

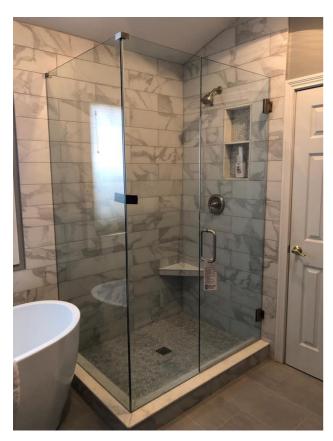
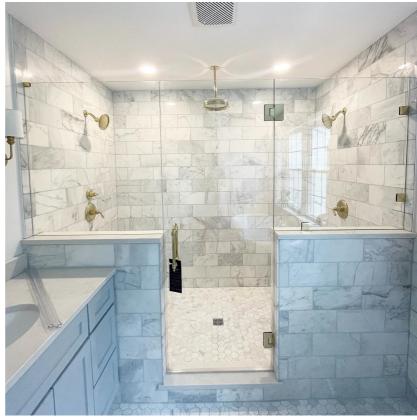
Please refer to the attached photos for comparison: one shows a well-lit application where the green hue is barely noticeable, and the other demonstrates a setting with less lighting, where the green tint is more apparent.

The green tint often seen in glass is caused by iron content used during the manufacturing process. While some find this green hue appealing, others prefer a clearer look. To address this, low-iron glass is available, which significantly reduces the green coloration.

Over the years, we've observed that strong lighting within a shower—particularly when it's brighter than the surrounding area—can make the green hue virtually disappear.
